The Pawley House (38GE15)

THE PAWLEY HOUSE (38GE15)
(Research Manuscript Series No. 16, Oct. 1971)

by Stanley South

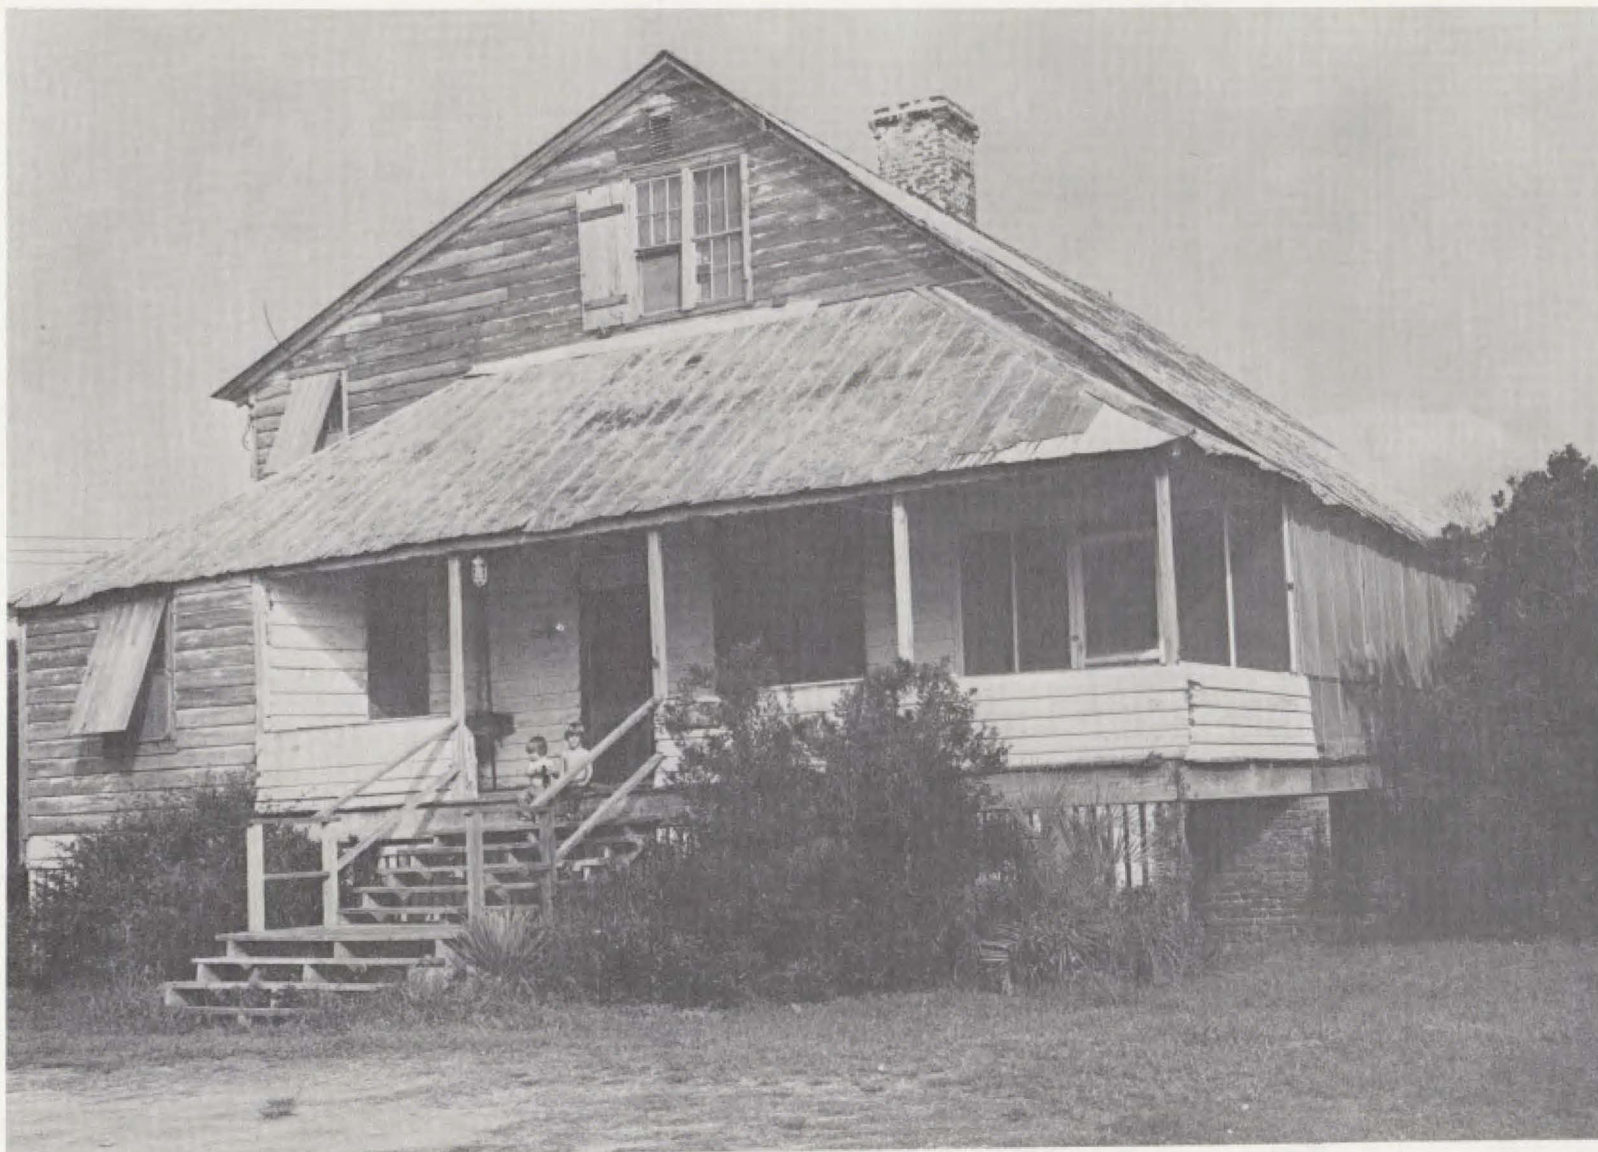
FIGURE 1. The view of the west front of The Pawley House as seen from U.S. Highway 17. The beach is located behind the house to the east. Notice the weatherboard seams revealing the original roof line against the end of the house above the porch.

The house is not particularly impressive as viewed from U.S. Highway 17 (Fig. 1). It has a patched tin roof, a screened south porch, an open west porch, and a roof that has been raised along the north side (Fig. 1). The evidence for the raised roof can be seen in the weatherboard joints which reveal the line of the original roof (Fig. 1).

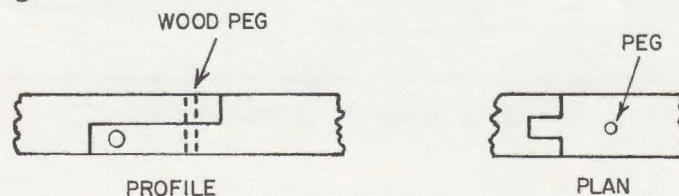
The overhead timbers on the porch are original, but the roof has been replaced. The timbers at the junction of the west and south porch are anchored by a large heavy iron angle at the junction of the roof beam to the partition wall. The porch roof beam has a U-splice at various intervals as seen here, utilizing tongue and groove and lap splice with pegs.

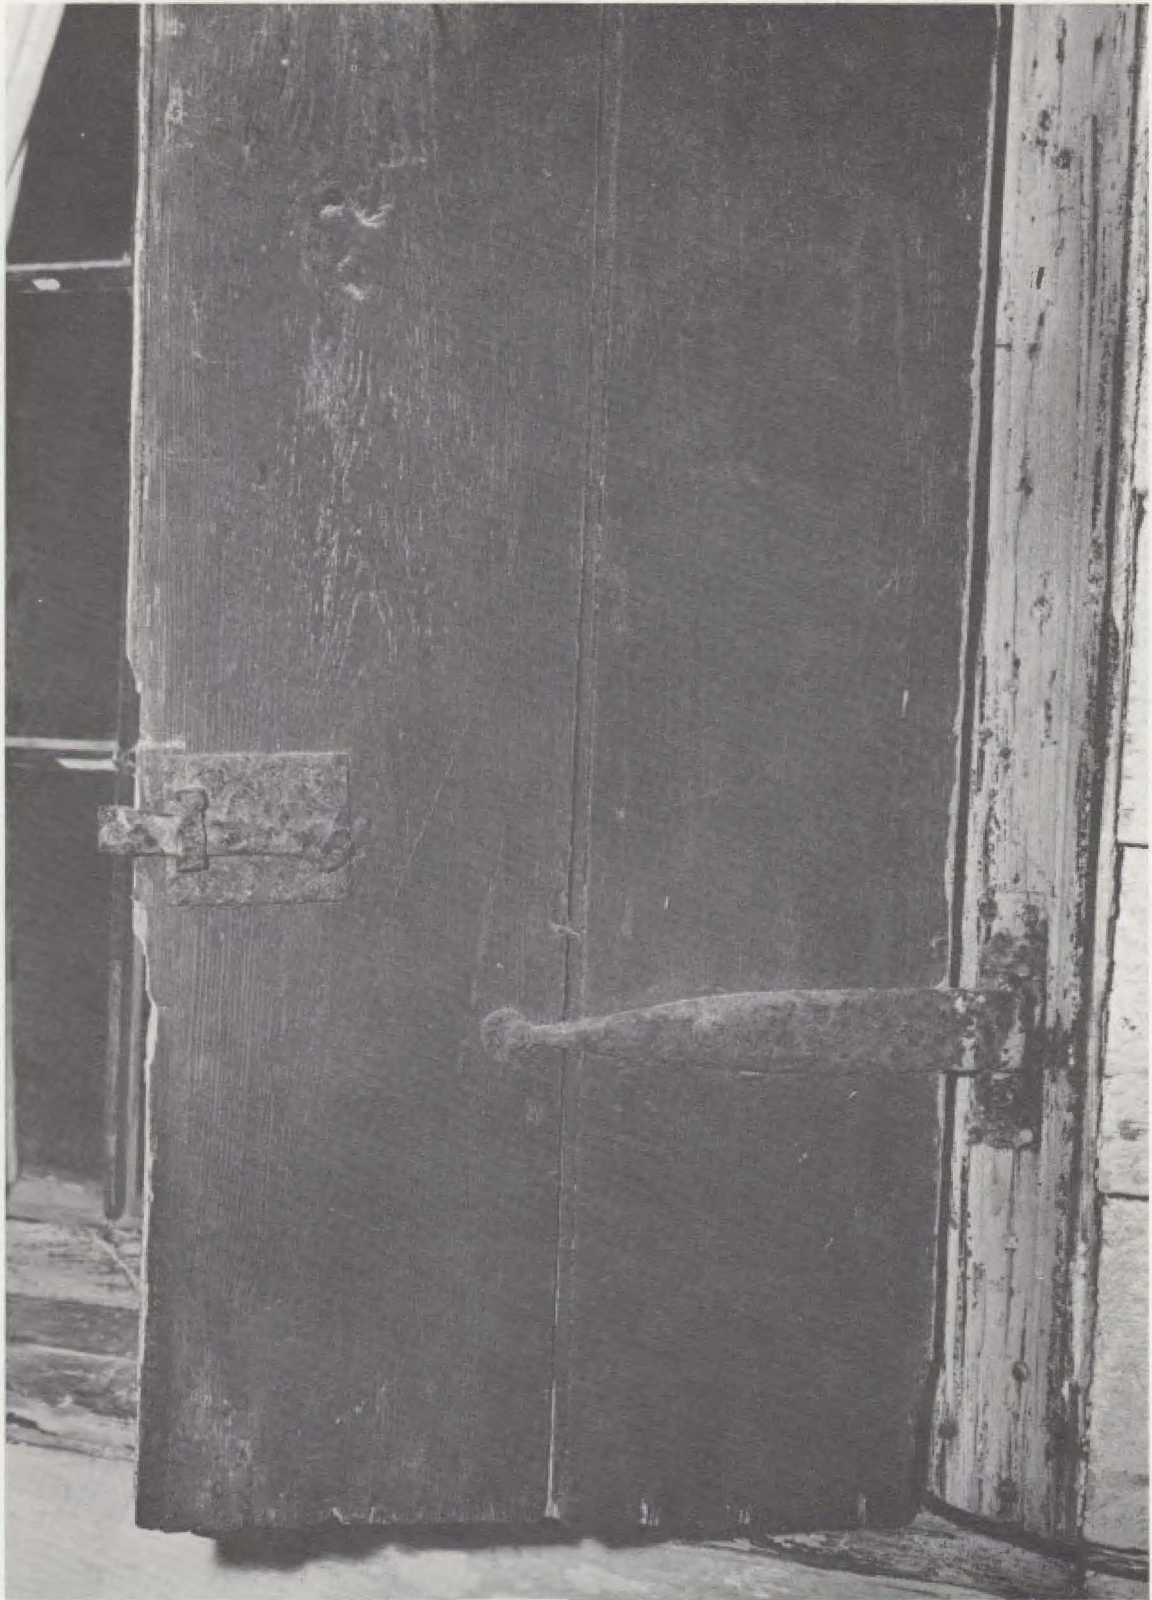
FIGURE 2. The exterior of the shutters showing the eighteenth century lift latch and wrought iron strap hinge with plate type pintel mounted with wrought nails. Notice the beaded shutter boards and beaded window frame.

The original porch columns are missing, but the sockets where they engaged the overhead beam for the porch are still evident. The shutters for the window on the west porch wall have a lift type iron shutter latch and strap hinges, with plate type pintles mounted onto the window frame (Fig. 2). The shutter is made of two battened boards, with both the boards and the battens being beaded with the groove typical of eighteenth century construction (Figs. 2 and 3). The window frame is also constructed with beaded timbers. Iron screws and wrought nails were used to fasten the original hardware. An iron shutter locking bar was used for fastening the shutter in a closed position. These pieces of shutter hardware are like those recovered from the ruins of Russellborough in Brunswick Town, North Carolina, the colonial mansion home of Governors Arthur Dobbs and William Tryon (South 1967: 360). Russellborough was begun in 1752, but was not completed until 1758, and was burned in 1776 (South 1967: 360-365).

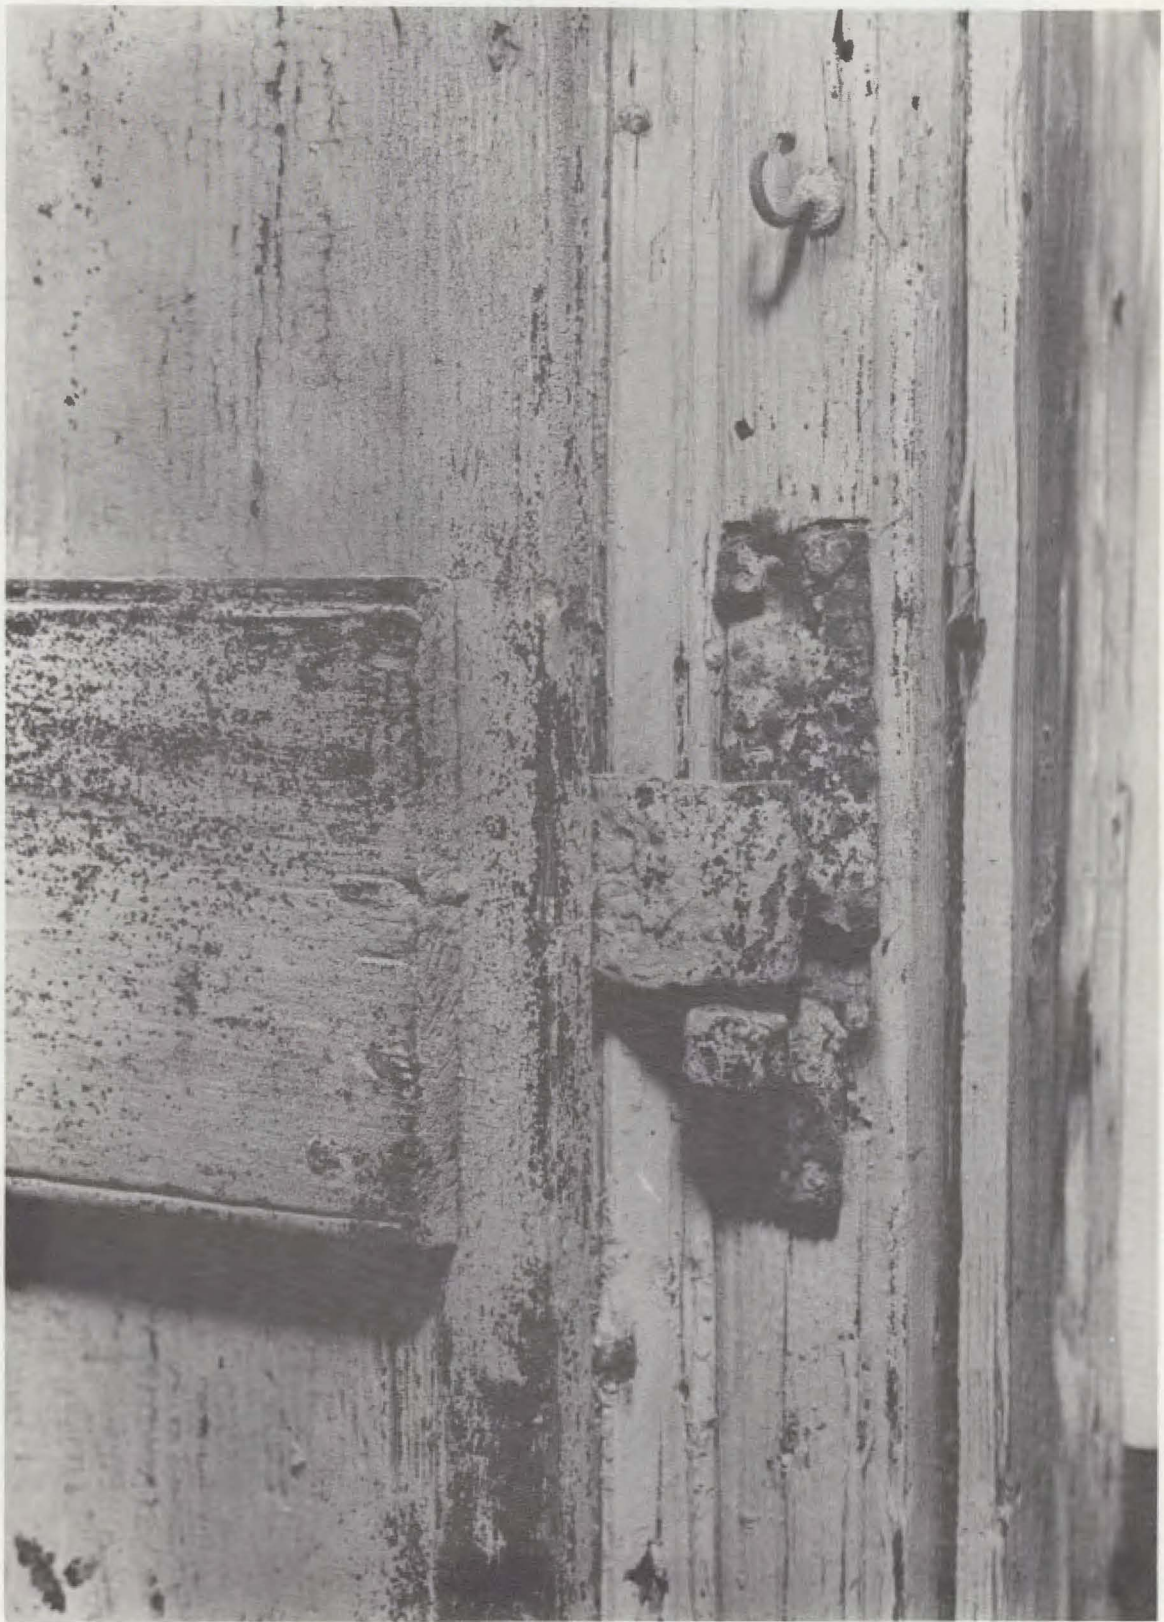
FIGURE 3. The interior of the shutter showing detail of beaded batten board and strap hinge on plate type pintle.

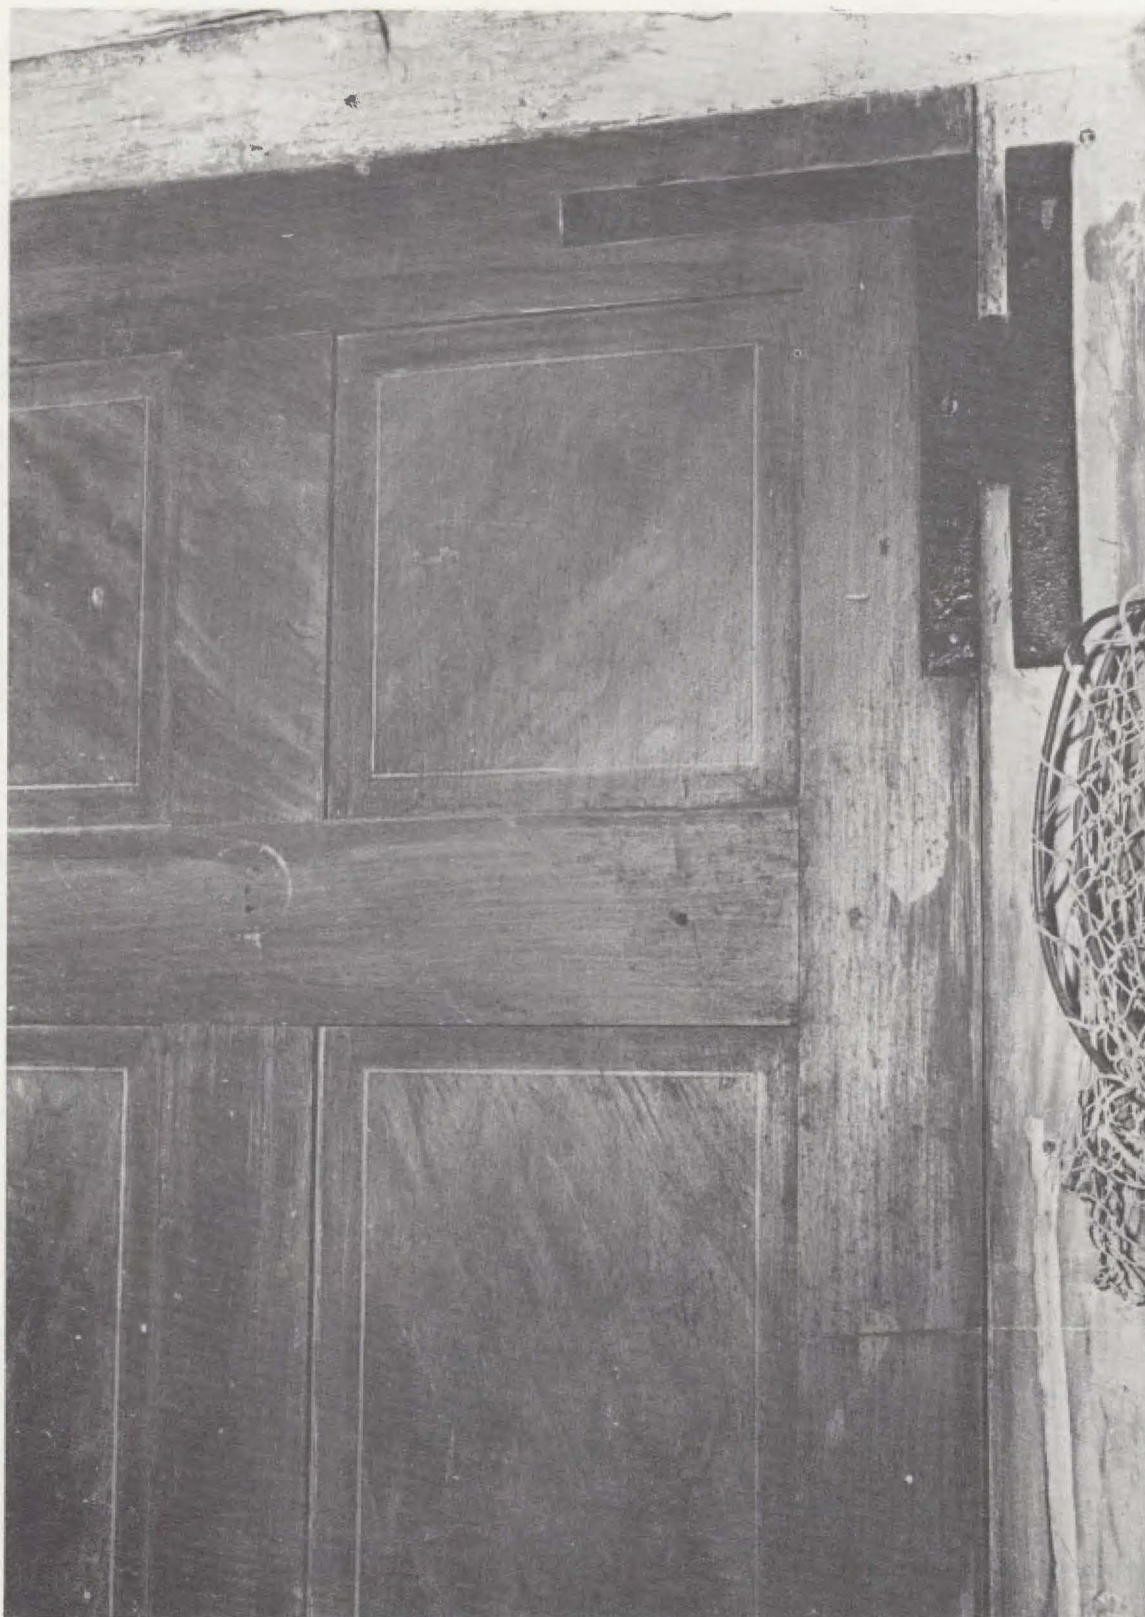
FIGURE 4. The northeast door to the west room revealing the detailed graining effect seen on many doors in the house. Note the imitation inlaid effect created by incising a line into the wet graining pattern on the panels.

The transom above the door to the west porch in this room has been removed by weatherboarding over it. The door is artificially grained with matching panels in imitation of mahogany, with an imitation bevel and line of pseudo-inlaid veneer around the panel. The door has six panels, with two small ones at the top. The door has been moved to its present position from elsewhere. Large HL hinges are on the doors in this room, but they also appear to be replacements. The northwest door in this room has no original door caseing, and cut nails were used in its construction, indicating a date probably after 1800 for its construction. The character of the doors, with their mahogany graining effect, is out of character with the whitewashed walls and were apparently moved from another structure, perhaps one with paneling matching that seen on the doors (Fig. 4).

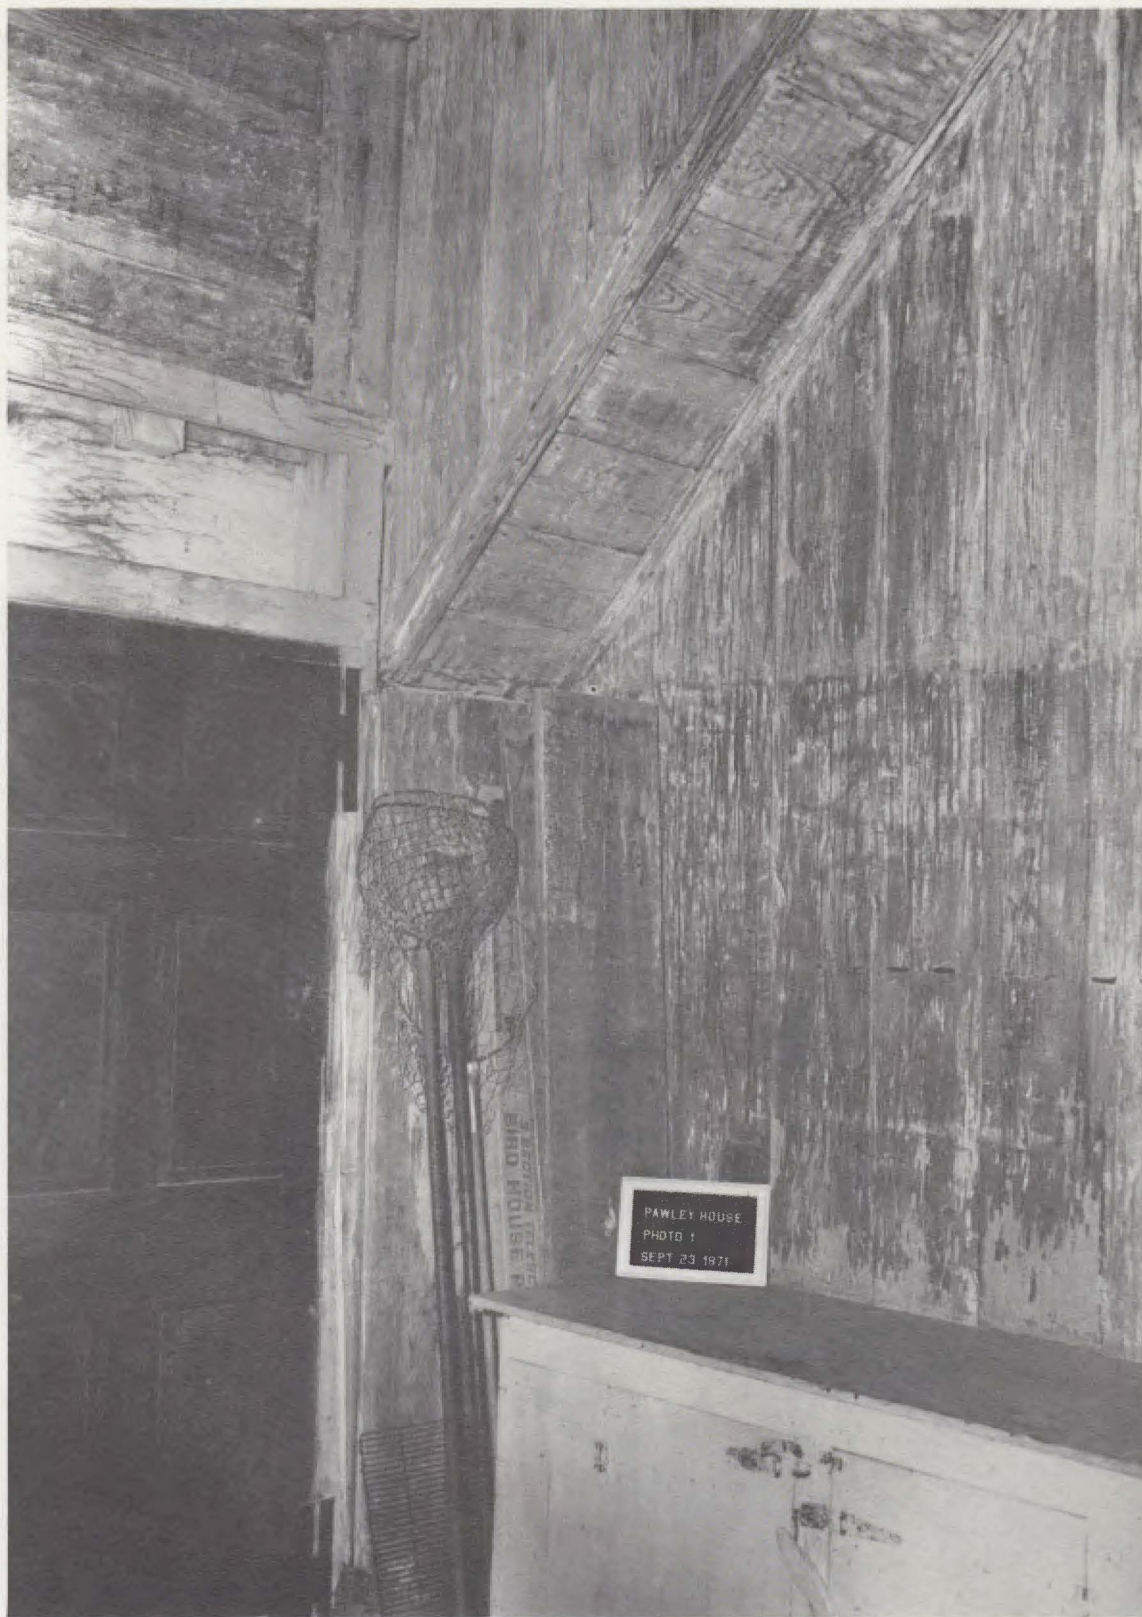
FIGURE 6. The northeast corner of the west room showing enclosed stairwell to the second floor. The transom was closed when the original porch was converted into living quarters. Notice the row of pegs, which is the top row of three for use in hanging clothes in lieu of closets. The boxed cabinet is a recent addition which enclosed a row of pegs apparently for use of children.

The fireplace is located against the east wall of the room, with a door to the east room located to the south of the fireplace, and an enclosed stairwell to the second floor located to the north of the fireplace. Beneath this stairwell, against the single-board-thick partition wall, an enclosed cabinet has been built in recent years. Above this

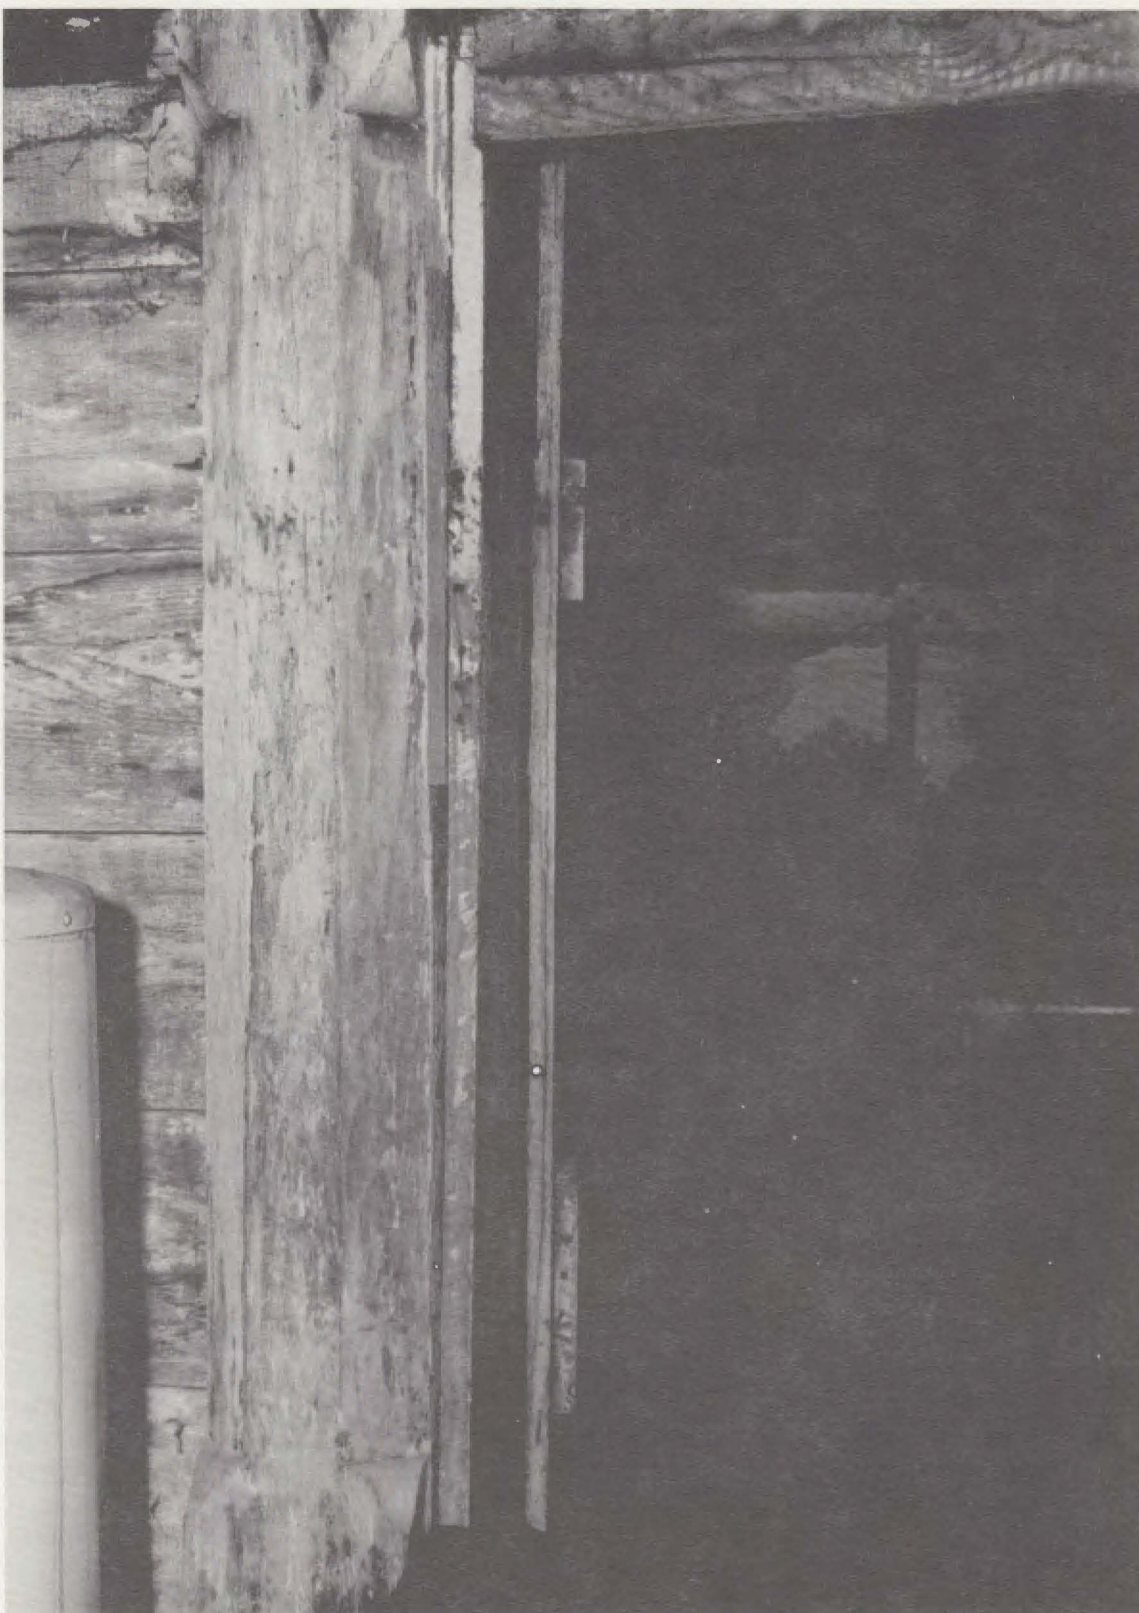
FIGURE 9. The original porch column located on the rear porch of The Pawley House. Notice the chamfered corners and ogee curve to the junction between the chamfer and the corner of the post. Posts such as this were apparently all around the porch originally but none remain on the south and west porches.

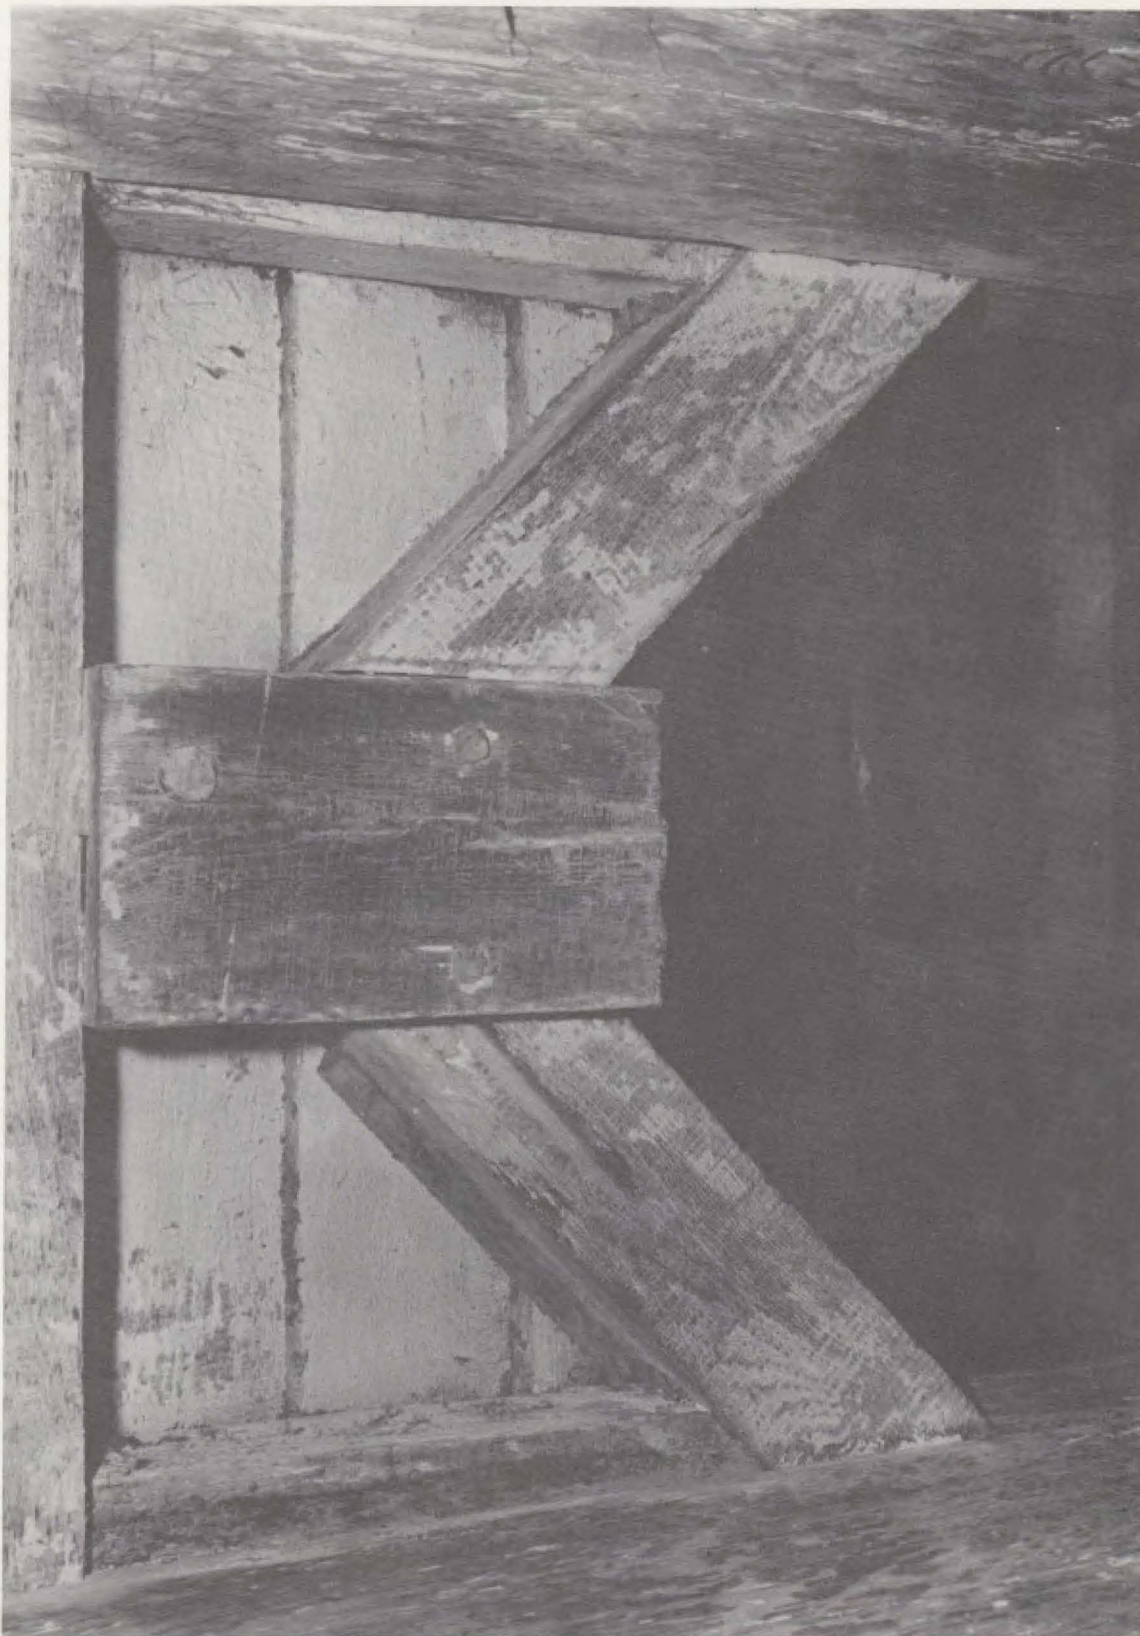
FIGURE 10. The timbered arch over the second floor stairwell showing the type of joining seen throughout the house. Notice the straight saw marks on the timbers, a characteristic of eighteenth century saw mills.

planed boards fastened with wrought nails. Overhead in the stairwell is a good example of the type of timber joining that is seen throughout the house (Fig. 10). The lack of weather wear on the back porch wall beside the stairs clearly reveals that this wall was not exposed to the elements.
